**TEARDOWN REPORT  
OF TWO MODEL TPE331-10T-515K TURBOPROP ENGINES  
SERIAL NUMBER P-79297C AND P-79001C**

**October 8, 2014**

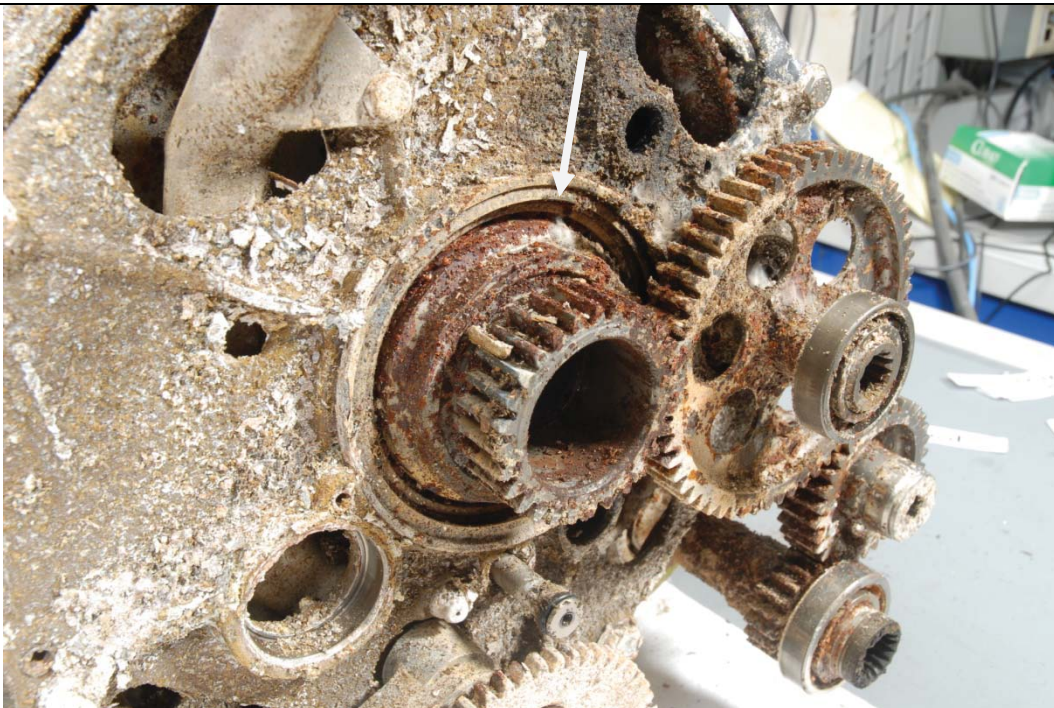
**Figure 241. P-79001C, Bull Gear**

- (f) Bull Gear (Figure 241):
  - The bull gear was not free to rotate.
  - The bull gear appeared to be intact but was not removed from the diaphragm assembly.

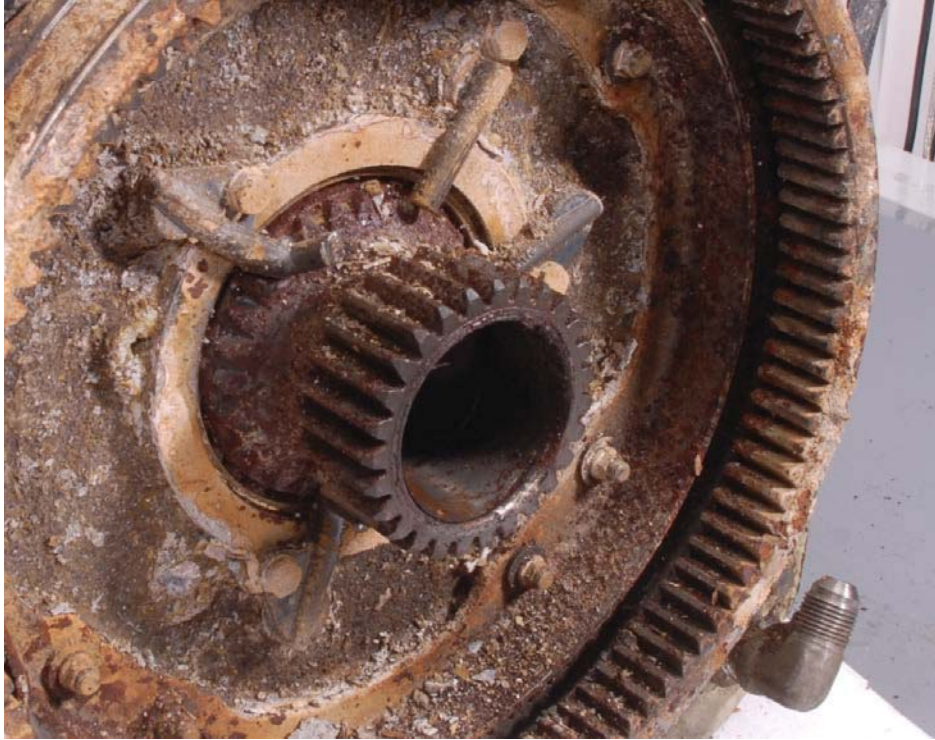
**Figure 242. P-79001C, Aft Bull Gear Bearing**

- The aft bull gear bearing and liner were displaced aft in the diaphragm housing. (Figure 242)
  - The aft bull-gear bearing appeared to be intact but was not removed from the diaphragm assembly.

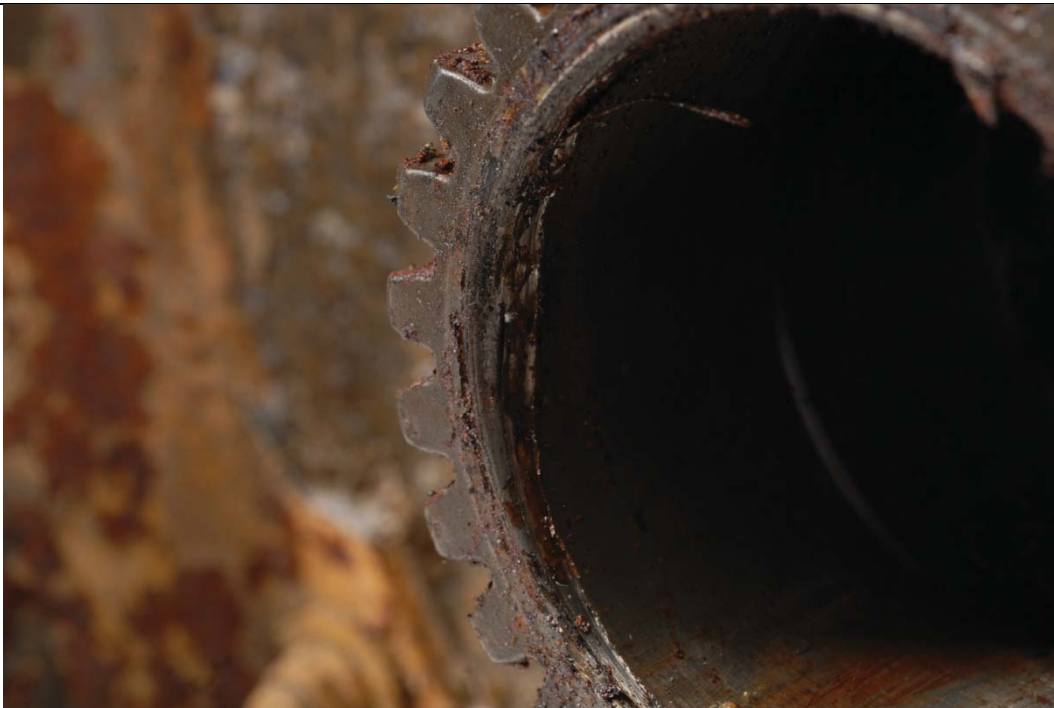
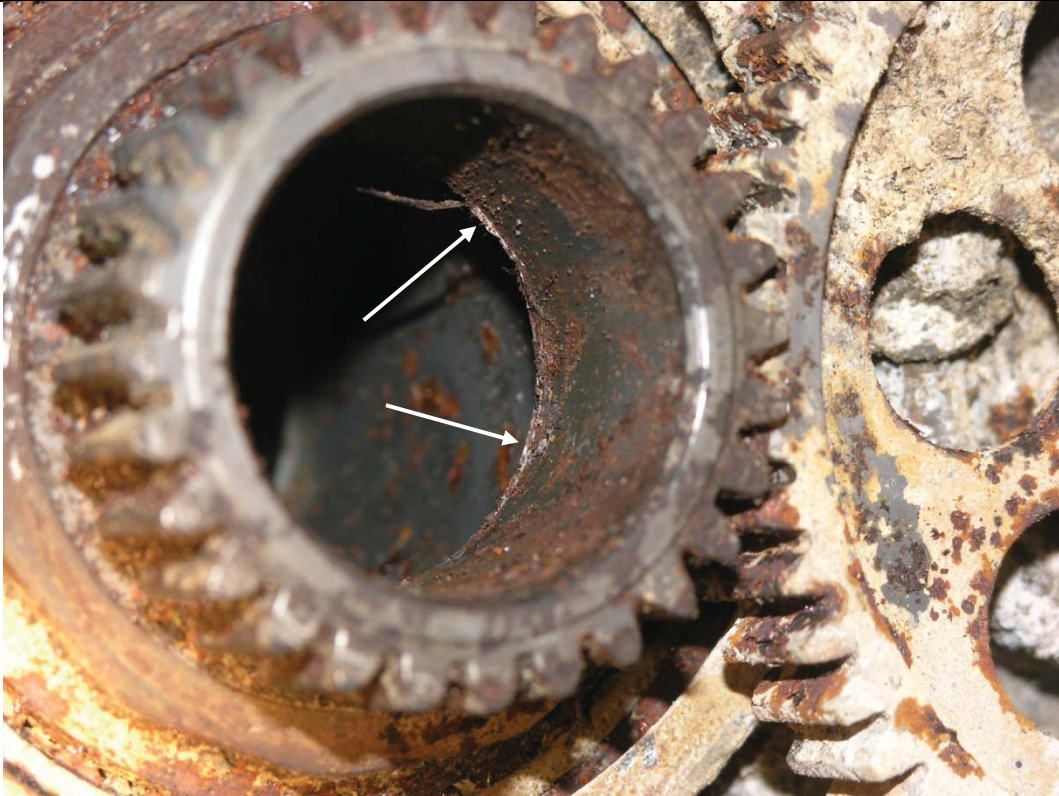
**Figure 243.** P-79001C, Sun Gear

- (i) Sun Gear:
  - The sun gear appeared was intact but was not removed from the diaphragm assembly. (Figure 243)
  - The sun gear displayed rotational scoring on the forward, inner bore leading edge (Figure 244) with corresponding score marks on the propeller shaft immediately behind the nut.

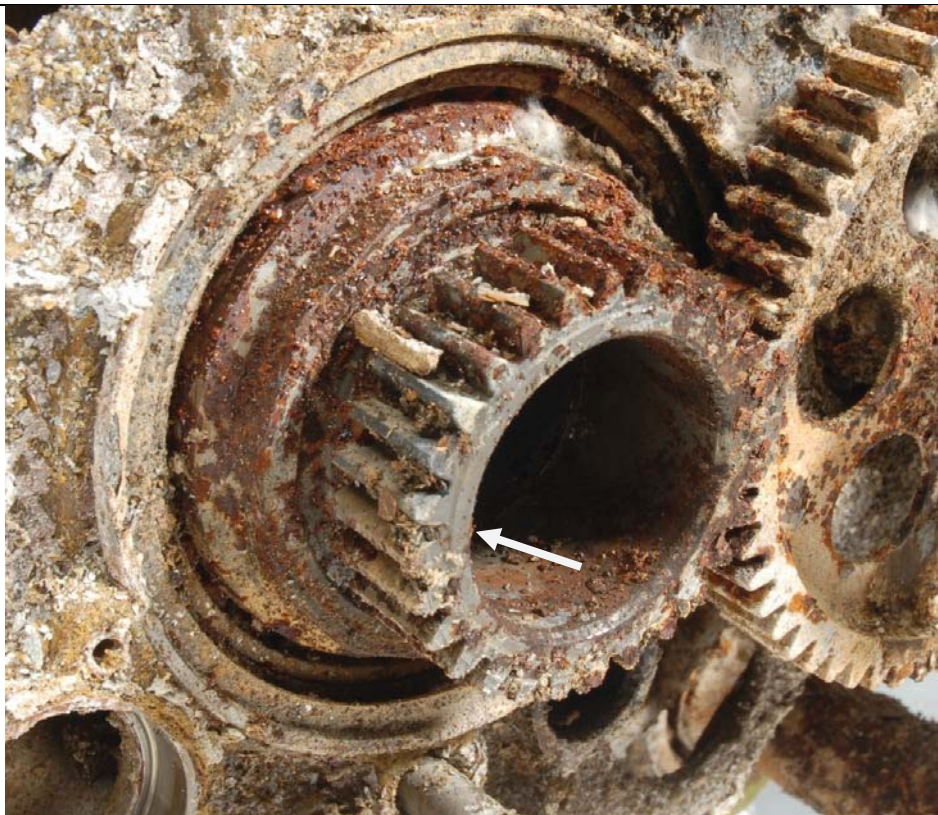
**Figure 245.** P-79001C, Aft Sun Gear, Rotational Scoring

- The sun gear displayed rotational scoring on the aft inner bore (Figure 245), with corresponding rotational score marks on 360 degrees on the aft taper of the propeller shaft.

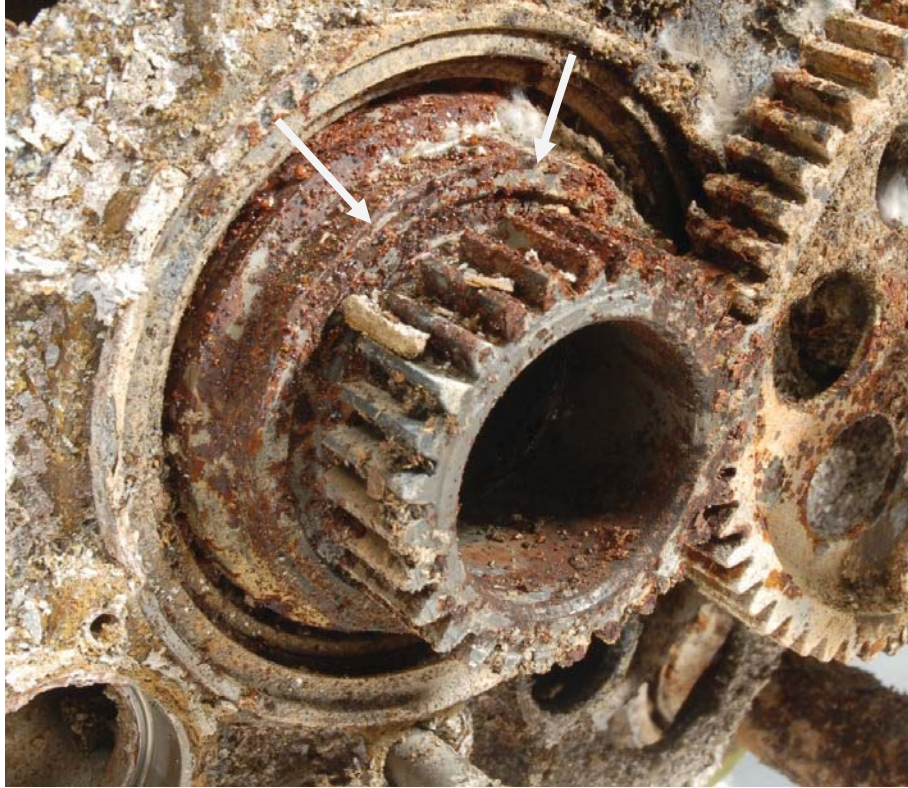
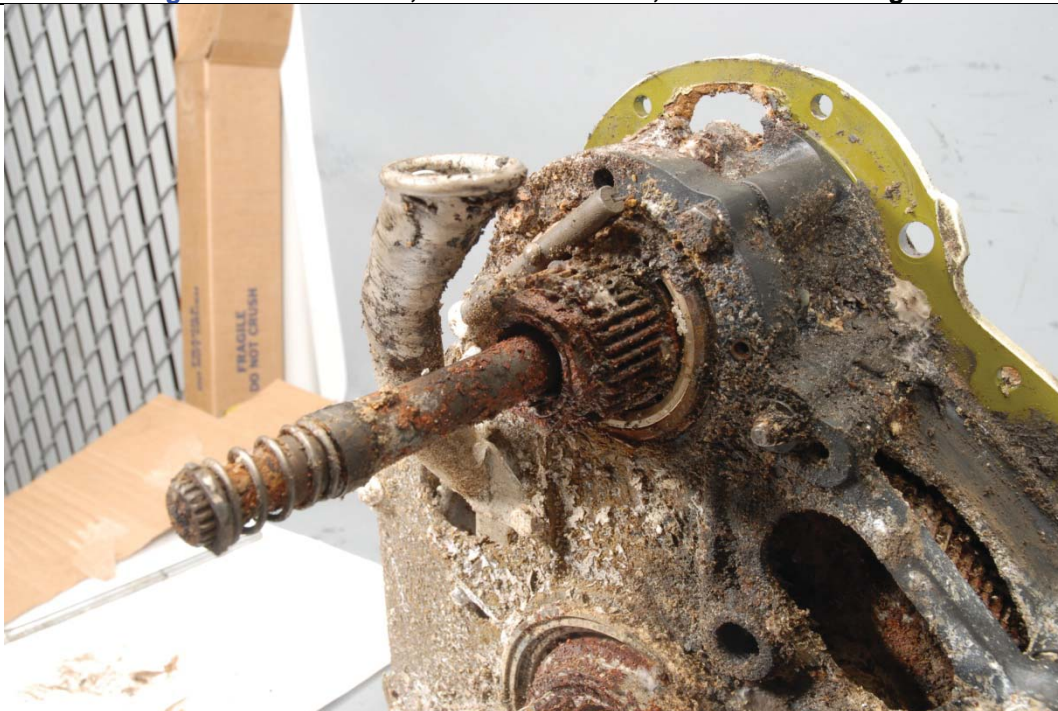
**Figure 246.** P-79001C, Aft Sun Gear, Rotational Scoring

- The sun gear displayed rotational scoring on the aft gear teeth. (Figure 246)
  - The bull/sun gear nut displayed rotational scoring (Figure 247) with corresponding rotational scoring to the torque sensor housing.

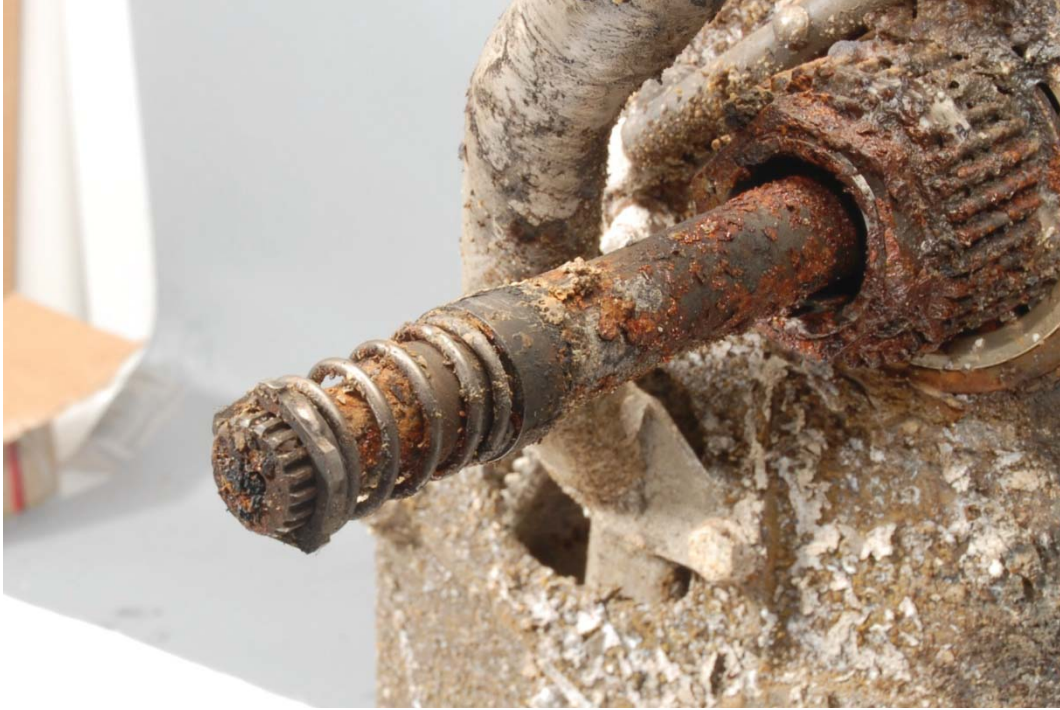
**Figure 248. P-79001C, High-Speed Pinion HSP**

- (j) High-Speed Pinion HSP: (Figure 248)
  - The HSP would not rotate.
  - The HSP was intact, but was not removed from the diaphragm assembly for a detailed inspection.

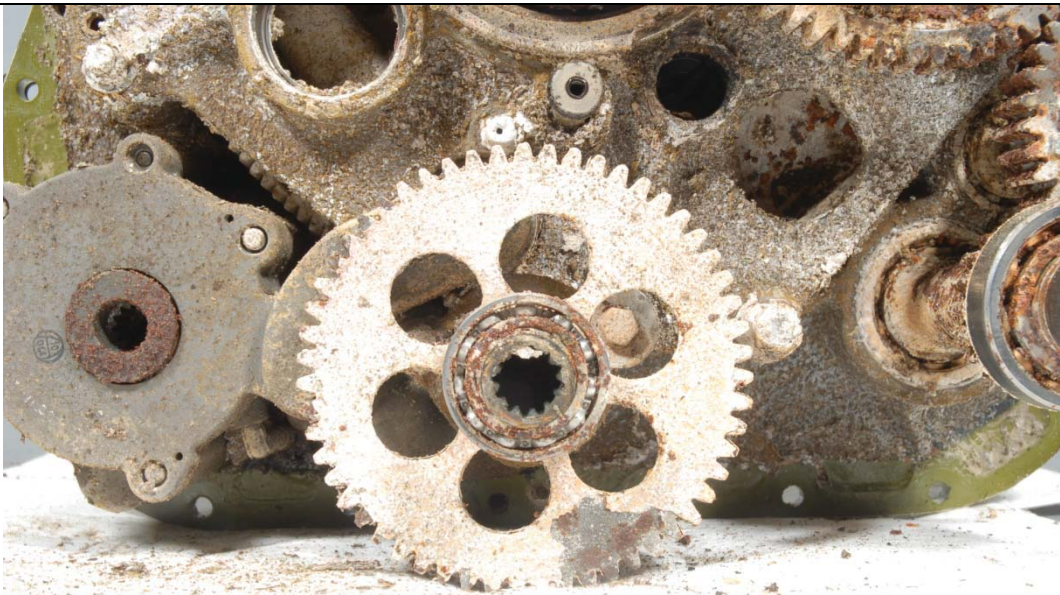
**Figure 249.** P-79001C, HSP-to-Power Section Coupling Shaft

- The forward high-speed pinion bearing was not free to rotate.
- (m) HSP-to-Power Section Coupling Shaft: (Figure 249)
  - The HSP-to-power section coupling shaft was intact.

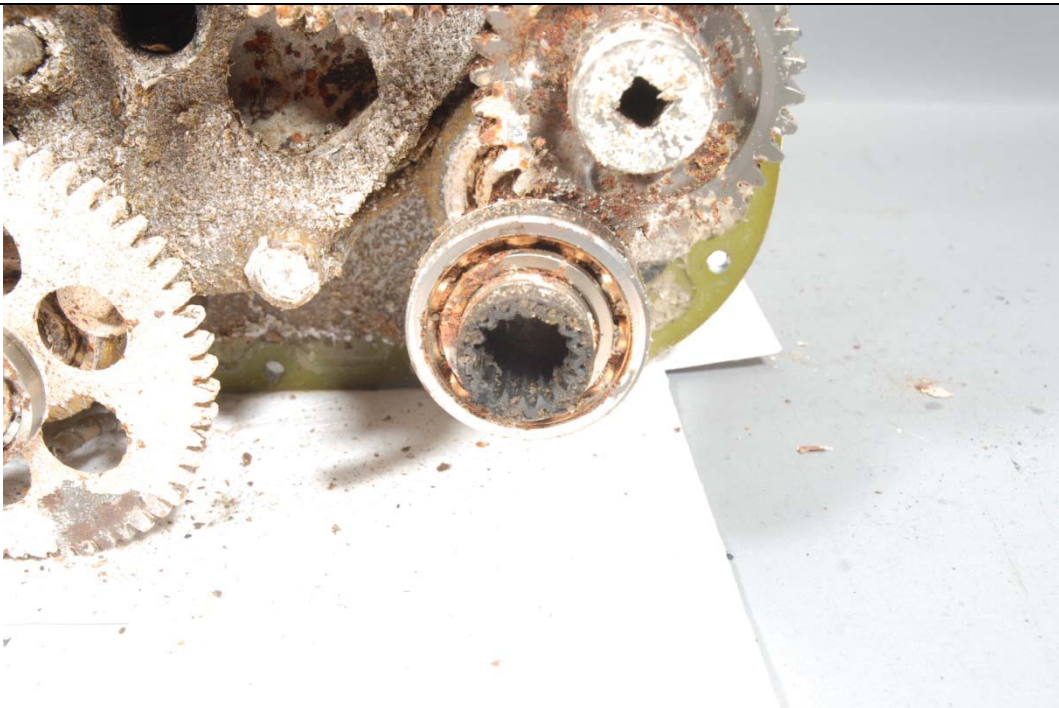
**Figure 251.** P-79001C, Propeller Governor Drive Gear Assembly

- (q) Propeller Governor Drive Gear Assembly: (Figure 251)
  - The propeller governor drive gear was intact.
  - The propeller governor drive bearings would not rotate.

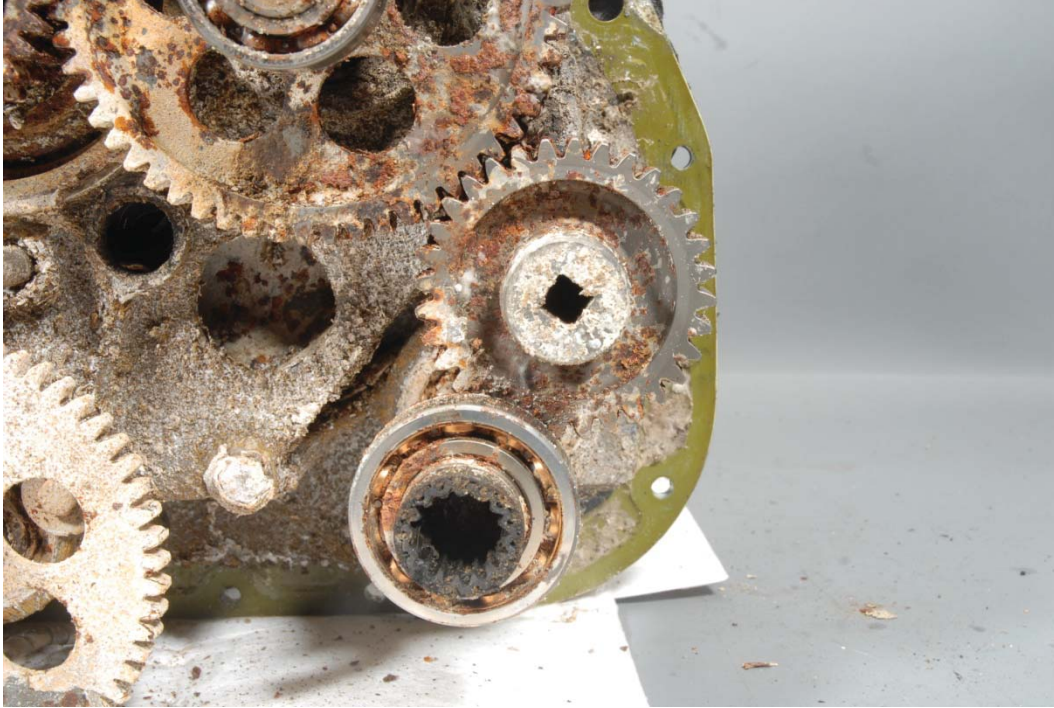
**Figure 252.** P-79001C, Starter/Generator Drive Gearshaft Assembly

- The propeller governor drive bearings were intact.
- (r) Starter/Generator Drive Gearshaft Assembly: (Figure 252)
  - The starter/generator drive gear was intact.

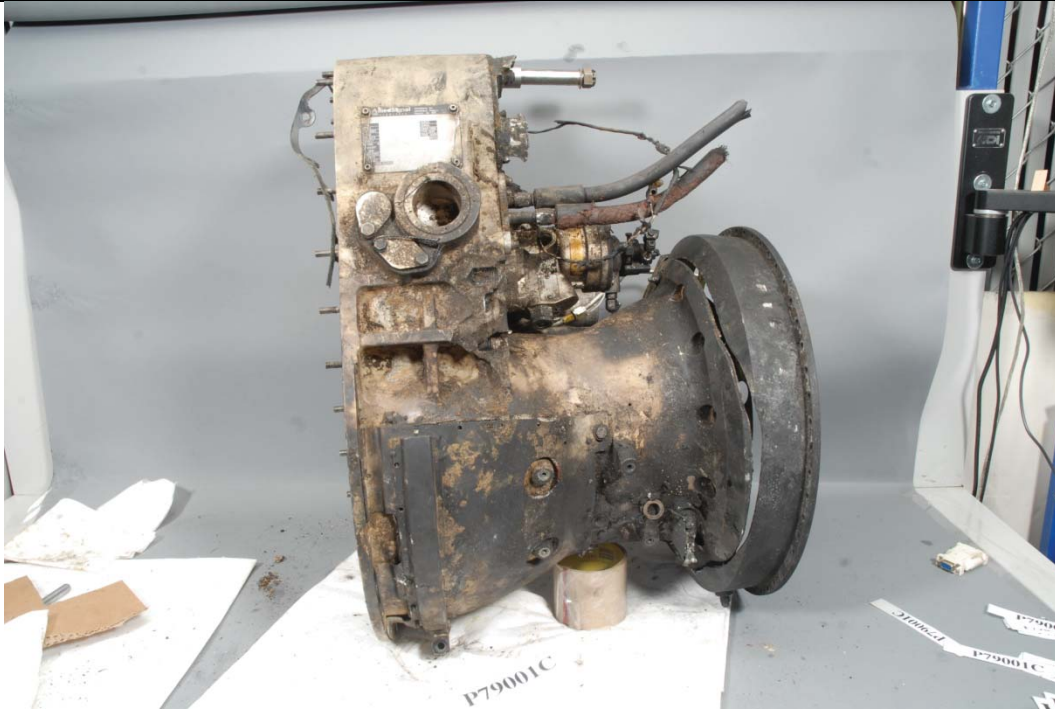
**Figure 254.** P-79001C, Gearcase Oil-Scavenge Pump Drive Shaft

- (t) Gearcase Oil-Scavenge Pump Drive Shaft: (Figure 254)
  - The gearcase oil-scavenge pump drive shaft could not be removed from the oil pump, but appeared to be intact.

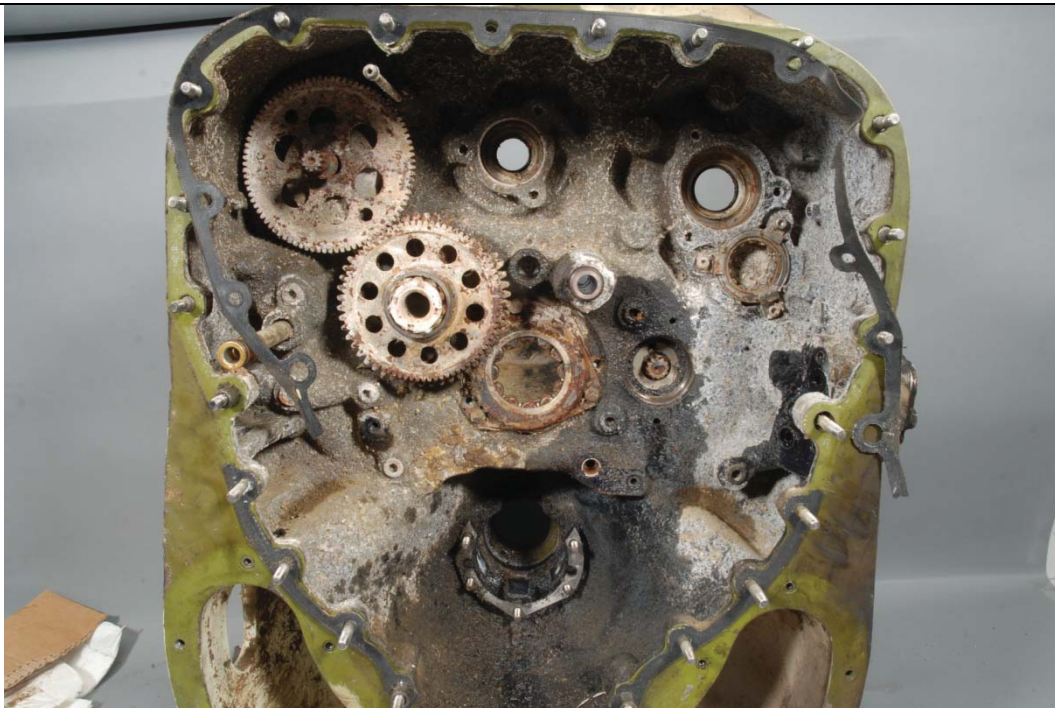
**Figure 255. P-79001C, Accessory Drive Housing (Gearcase)**

- (a) Exterior (non oil-wetted) Surfaces of the Gearcase Housing: (Figure 255)
  - The exterior of the accessory drive housing displayed damaged due to impact, with fracturing of the aft bolt flange and midsection.
  - The accessory drive housing had black colored debris consistent with fire soot adhering to the external surfaces.
  - The accessory drive housing had earthen debris adhering to the external surfaces.
- (b) Interior (oil-wetted) of the Gearcase Housing: (Figure 256)
  - The gearcase housing had earthen debris and corrosion materials adhering to the internal surfaces.
- (c) Anti-Ice Shield: (Figure 257)
  - The anti-ice shield was intact, but had some minor dents and fire damage.
  - The anti-ice shield was not removed for detailed inspection.

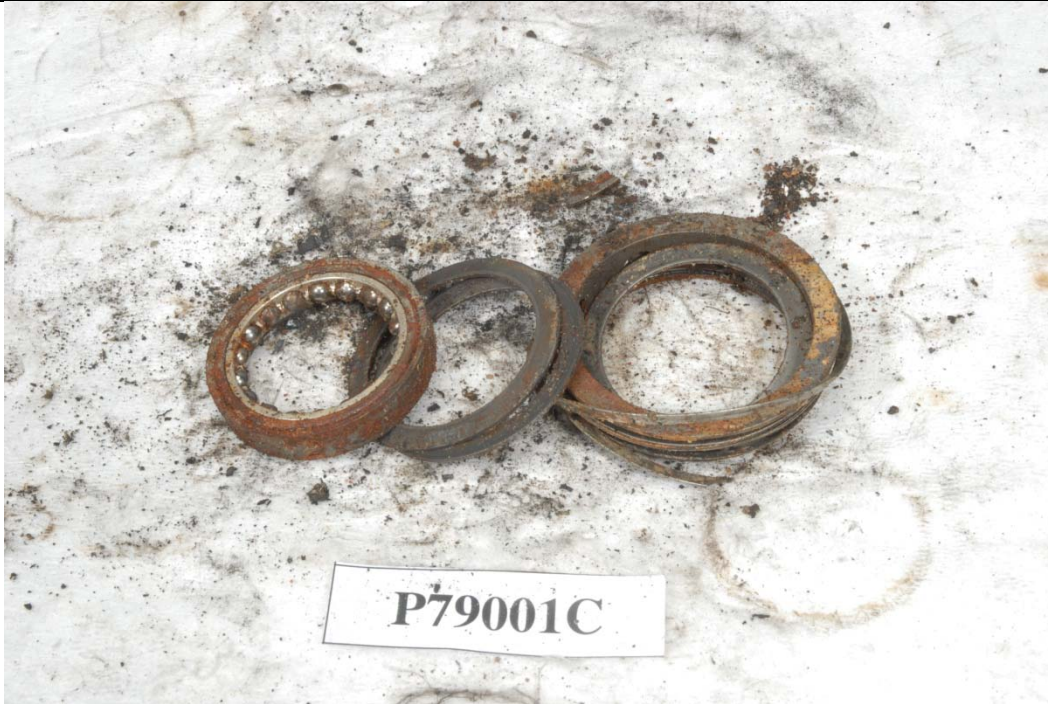
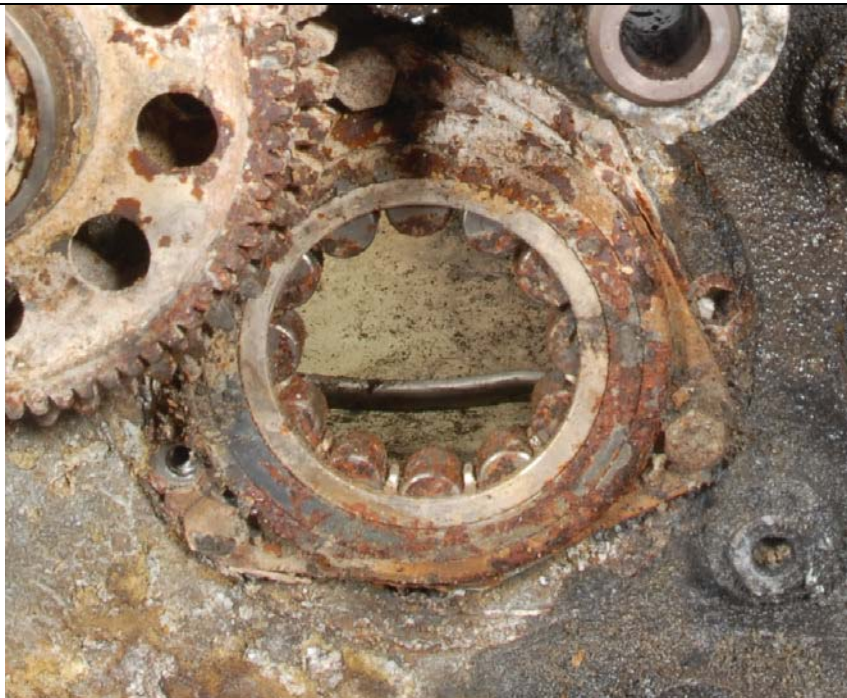
**Figure 258.** P-79001C, Propeller Shaft Aft Ball Bearing

- Service Bulletin TPE/TSE331-75-0004 was complied with. (Three air holes welded or riveted closed.)
- (d) Propeller Shaft Aft Ball Bearing: (Figure 258 and Figure 259)

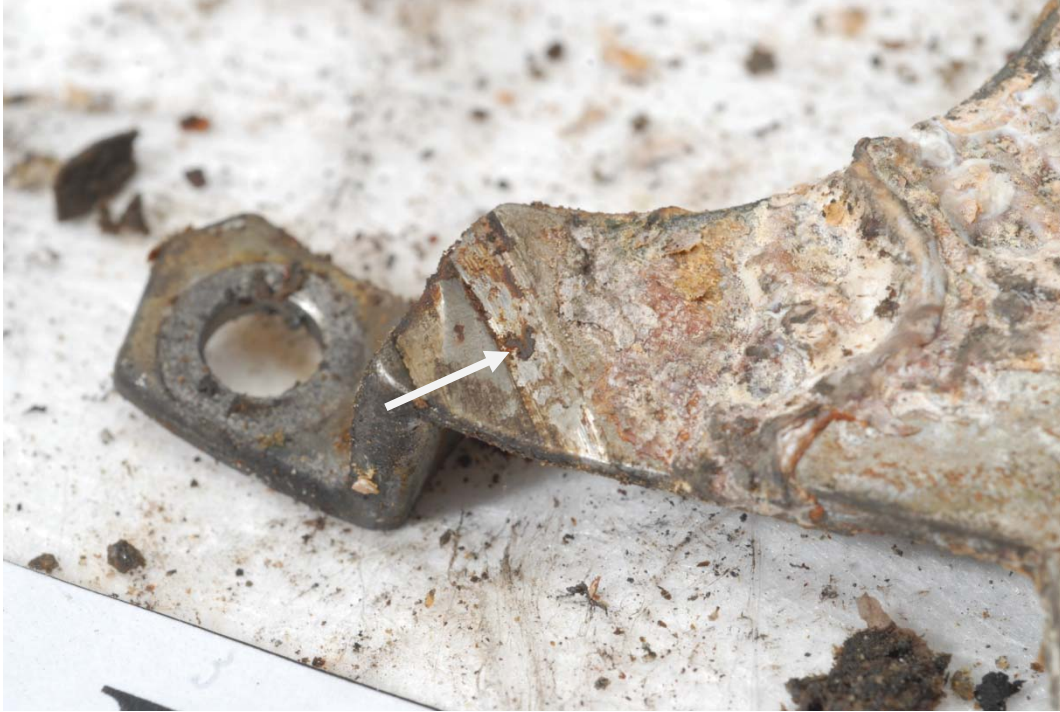
- Part Number: 3101726-3
  - Series Number: 2
  - Serial Number: P-3362C
  - The torque sensor housing displayed rotational scoring on the forward housing surface (Figure 280) with corresponding rotational damage to the sun gear nut.

**Figure 280.** P-79001C, Torque Sensor, Rotational Scoring

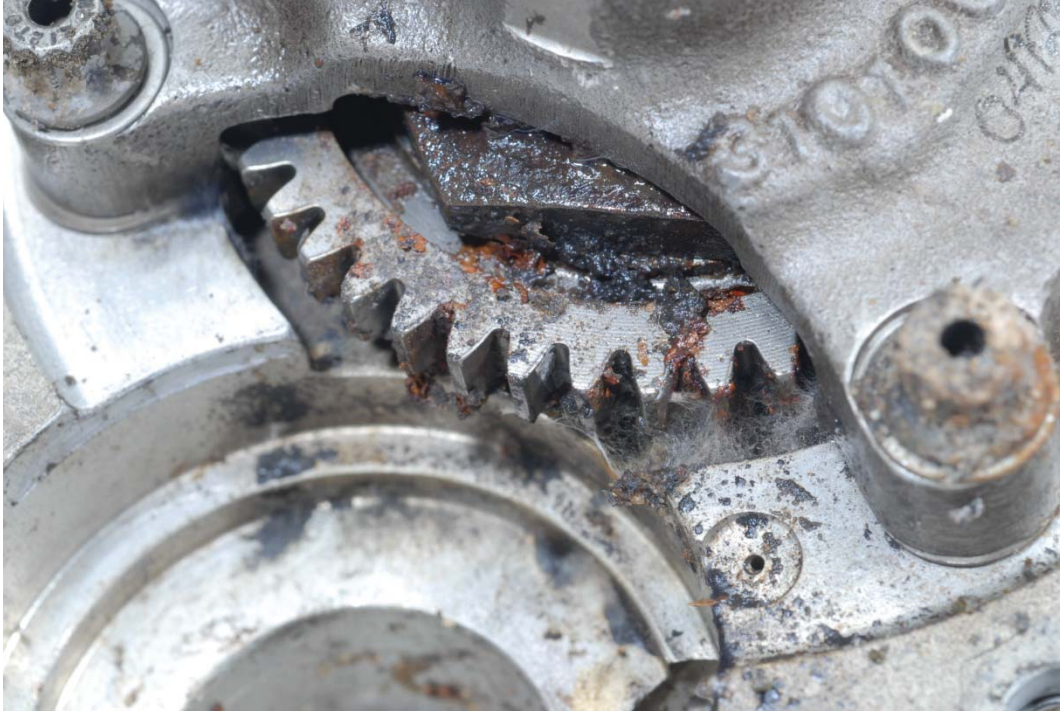
- (c) Helical Cam Gear: (Figure 282)
  - Prior to removal from the torque sensor housing, the helical cam gear was not free to rotate.
  - The helical cam external gear teeth were intact.

**Figure 282.** P-79001C, Helical Cam Gear

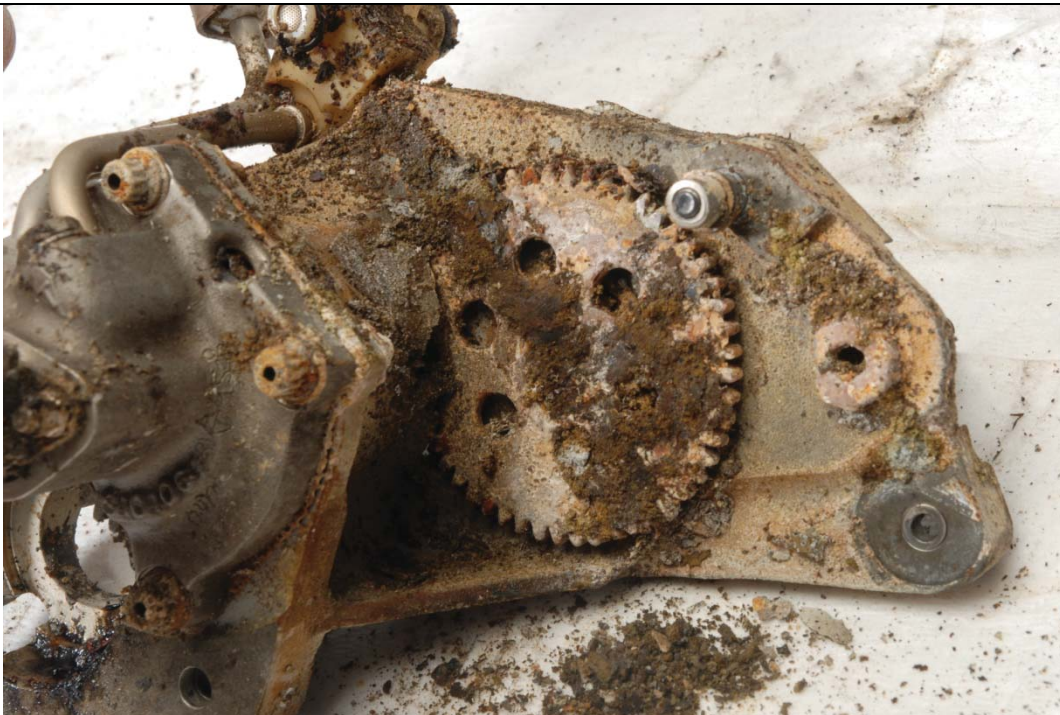
- (d) First Direct Drive Fuel-Control (DDFC) Gear Assembly (through the torque sensor housing):
  - The first DDFC gear was not free to rotate.  
The first DDFC gear appeared to be intact. (Figure 283)

**Figure 283.** P-79001C, First Direct Drive Fuel-Control (DDFC) Gear Assembly

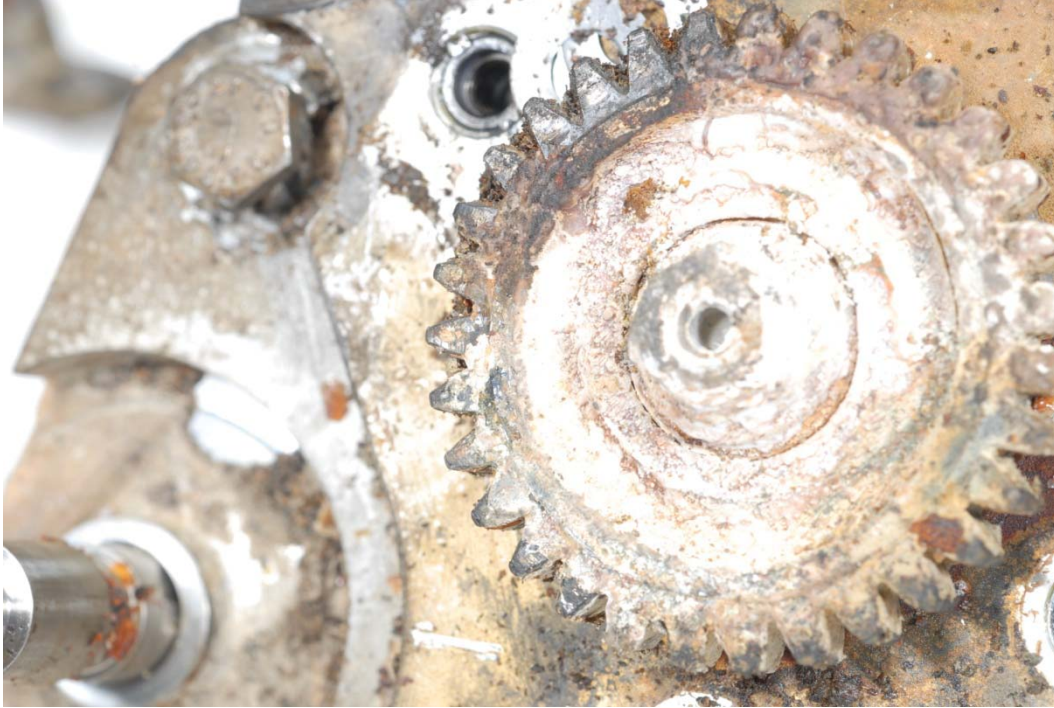
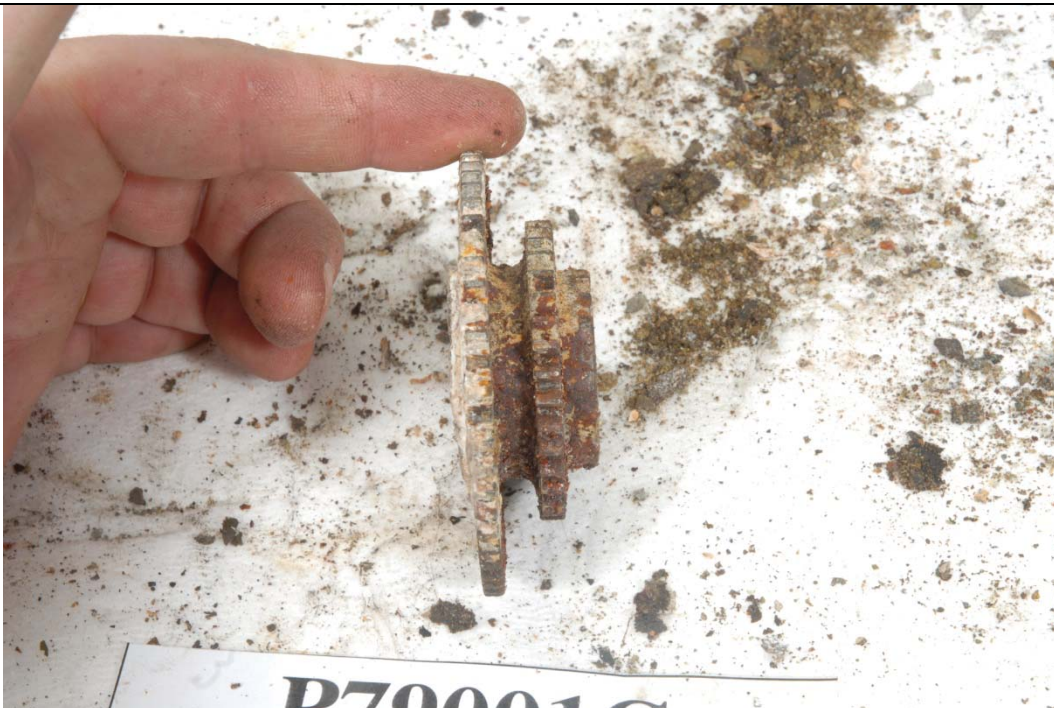
- (e) Second DDFC Gear Assembly (through the torque sensor housing): (Figure 284 and Figure 285)
  - The second DDFC gear assembly was not free to rotate.

- Both of the second DDFC gears were intact.
  - Both bearings of the second DDFC gear were intact, but were not accessed for detailed inspection.
- (f) Third DDFC Gear (double gear): (Figure 286)

**Figure 284.** P-79001C, Second DDFC Gear Assembly, ALF

**Figure 285.** P-79001C, Second DDFC Gear Assembly, FLA

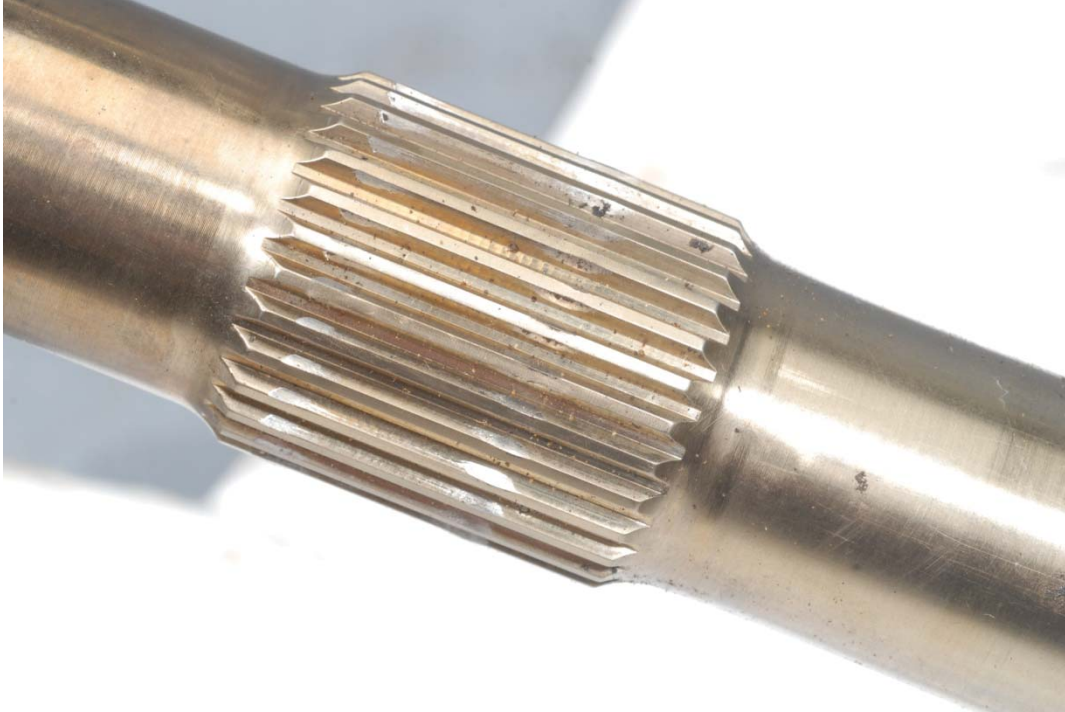
- (a) Shouldered (Main) Shaft: (Figure 288)
  - The shouldered (main) shaft displayed wear on face of the spline teeth that mate with the center curvic spline teeth. (Figure 289) The shaft otherwise appeared undamaged.

**Figure 288.** P-79001C, Shouldered (Main) Shaft and First-Stage Compressor Impeller

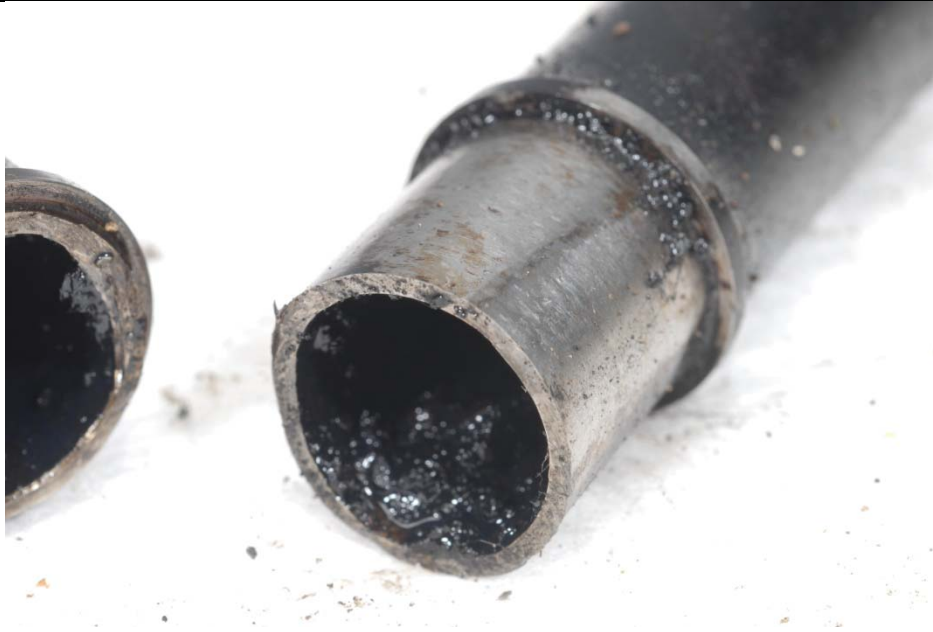
- (b) Torsion Shaft: (Figure 290)
  - The torsion shaft was separated in the area adjacent to the aft bushing. The torsion shaft was not submitted for material analysis. However, the characteristics of the fracture surfaces were typical of a torsional overload separation. (Figure 291)

**Figure 290.** P-79001C, Torsion Shaft

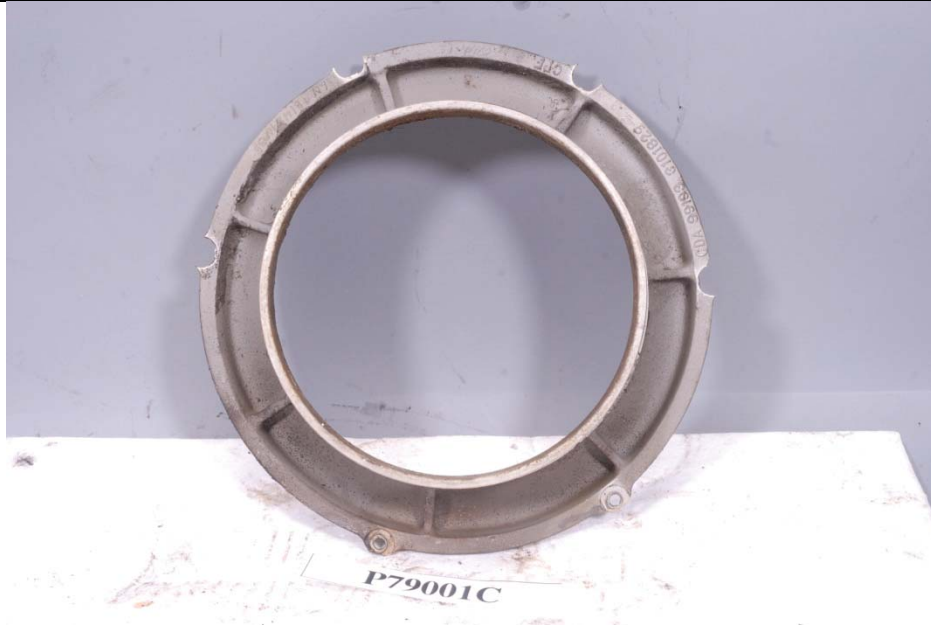
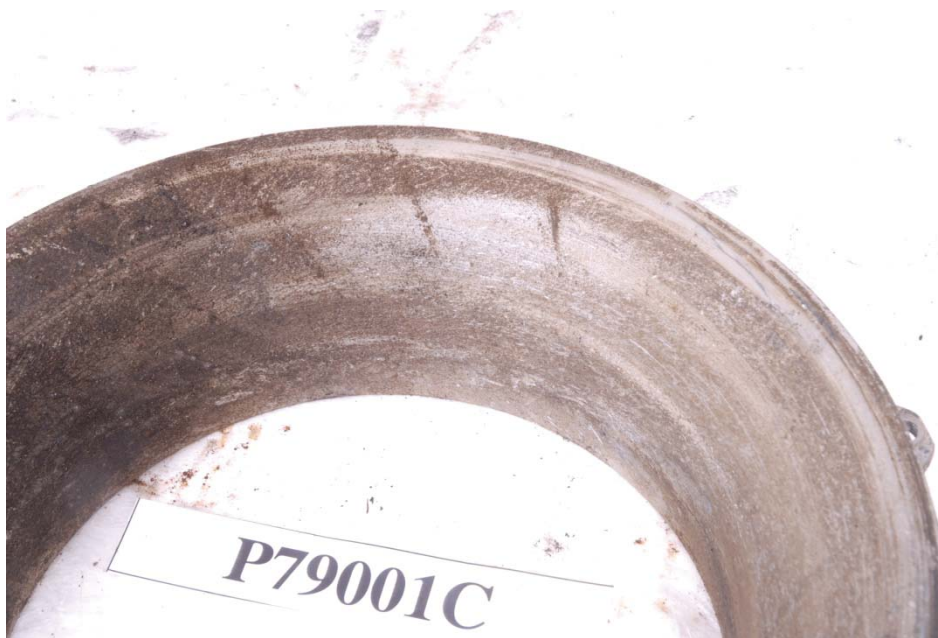
- (c) First-Stage Compressor Impeller Shroud: (Figure 292 and Figure 293)
  - The first-stage compressor impeller shroud displayed a shroud rub through approximately 360 degrees at the inducer and exducer areas (Figure 294) with corresponding rotational scoring on the impeller vane shroud line edge.

- The first-stage compressor impeller shroud had 4 mount bolt flanges broken.
- (d) First-Stage Compressor Impeller: (Figure 295 and Figure 296)
  - Part Number: 3108182-2

**Figure 292.** P-79001C, First-Stage Compressor Impeller Shroud, ALF

**Figure 293.** P-79001C, First-Stage Compressor Impeller Shroud, ALF

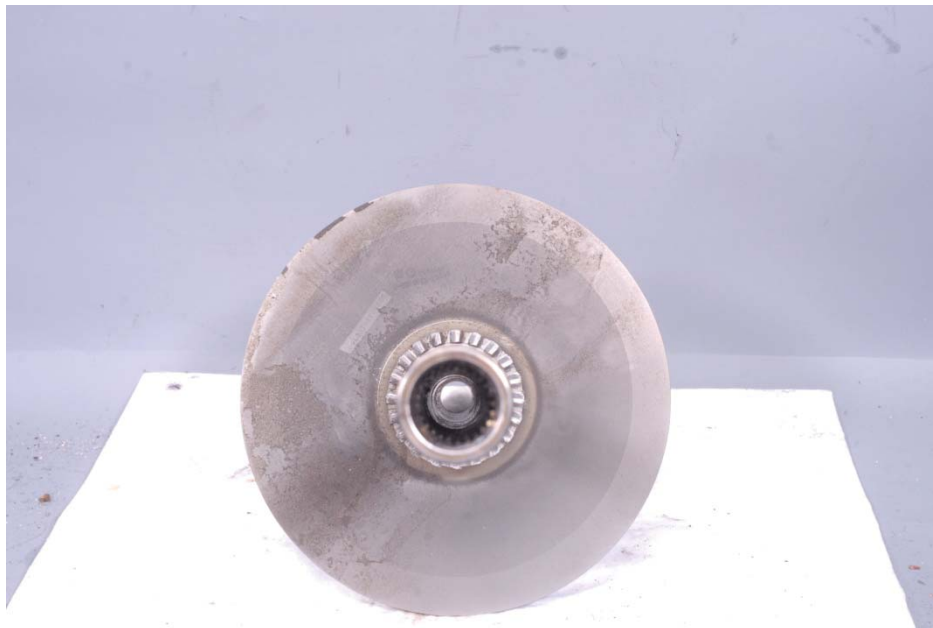
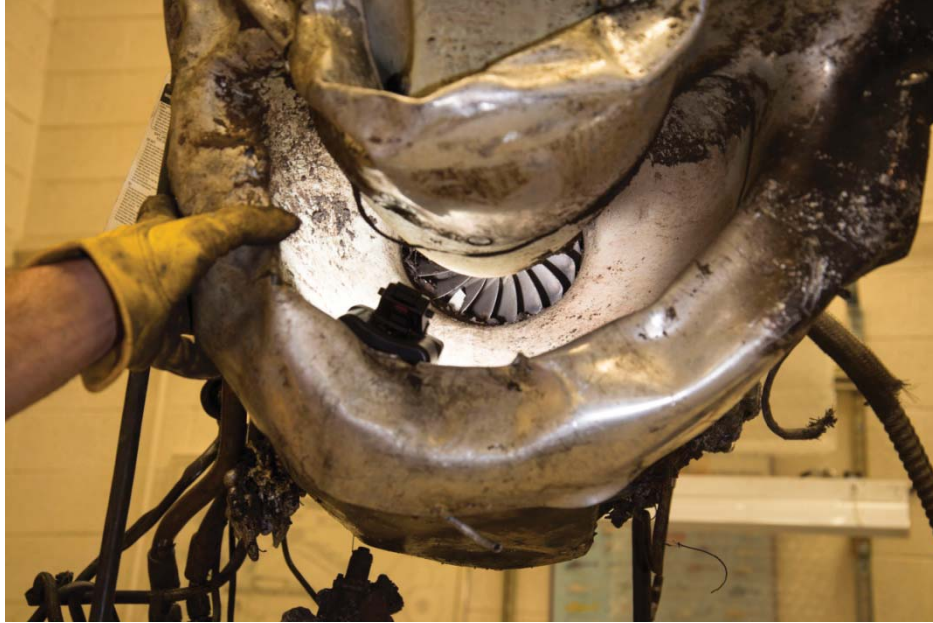
- There was earthen debris adhering to the first-stage compressor impeller vanes and flow path surfaces.
  - The first-stage compressor impeller displayed rotational scoring on the blade shroud line edge (Figure 298 and Figure 299) with corresponding rotational scoring on the first-stage compressor impeller shroud.

**Figure 295.** P-79001C, First-Stage Compressor Impeller, FLA

**Figure 296.** P-79001C, First-Stage Compressor Impeller, ALF

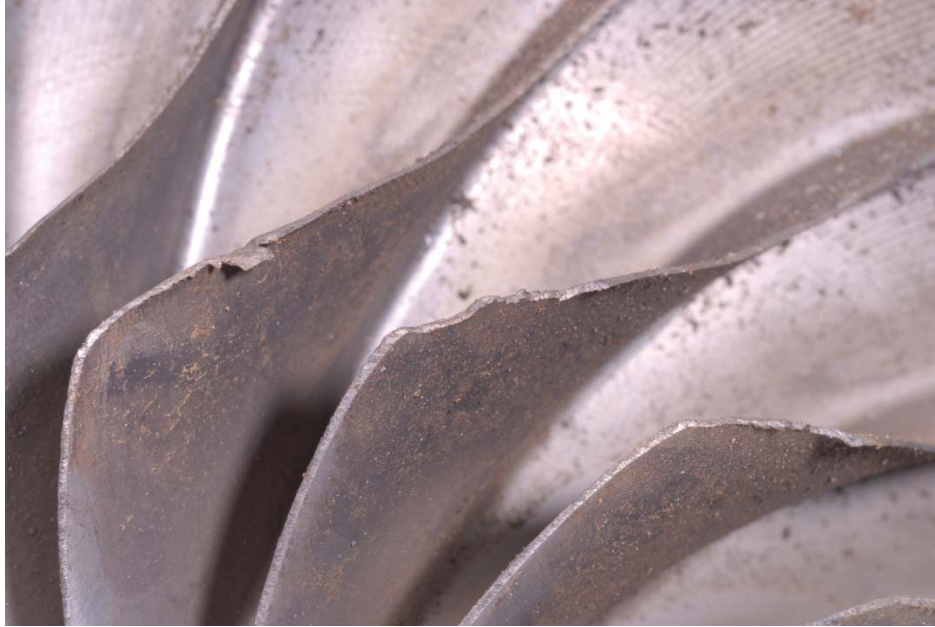
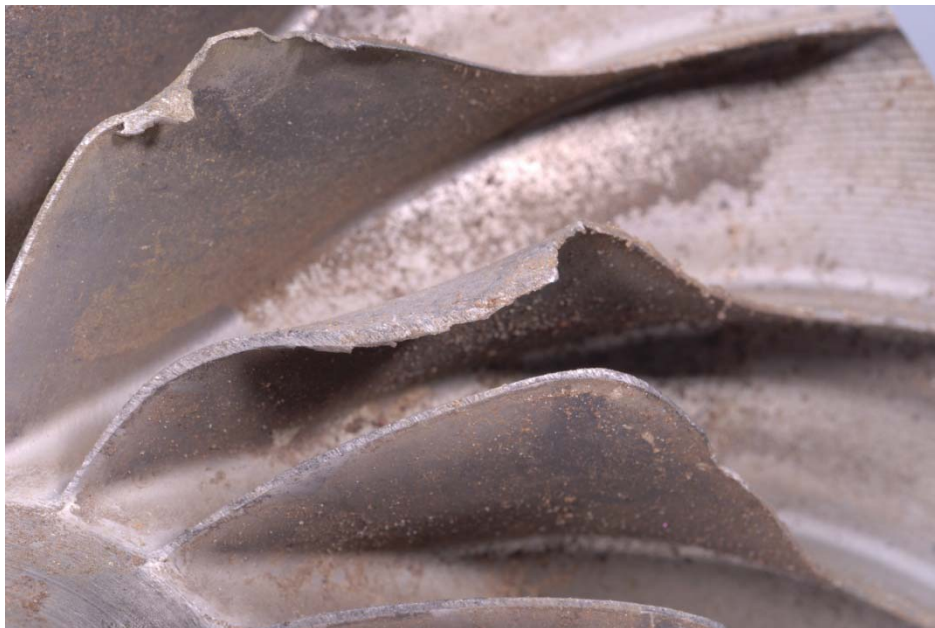
**Figure 298.** P-79001C, First-Stage Compressor Impeller, Rotational Scoring

**Figure 299.** P-79001C, First-Stage Compressor Impeller, Rotational Scoring

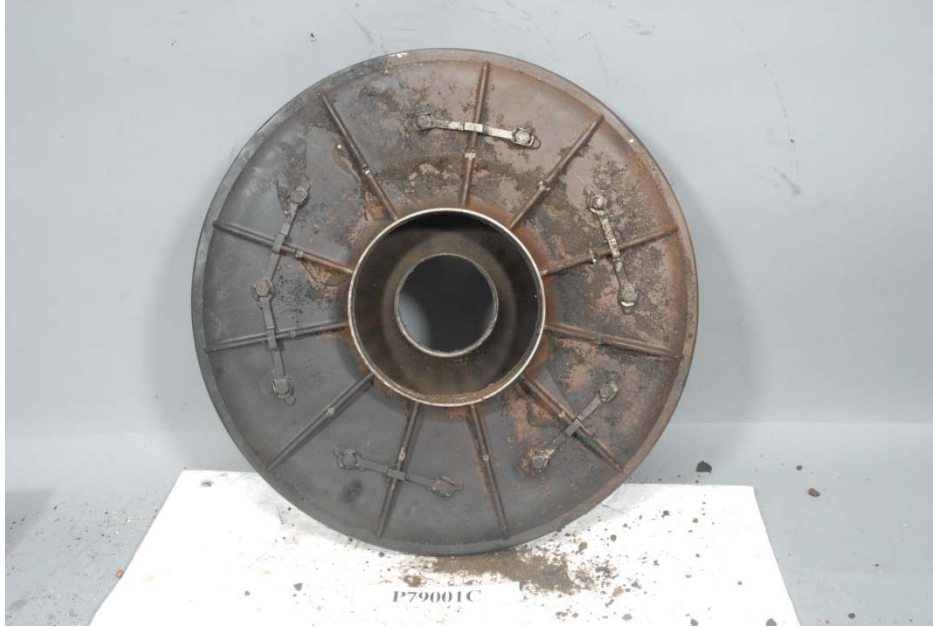
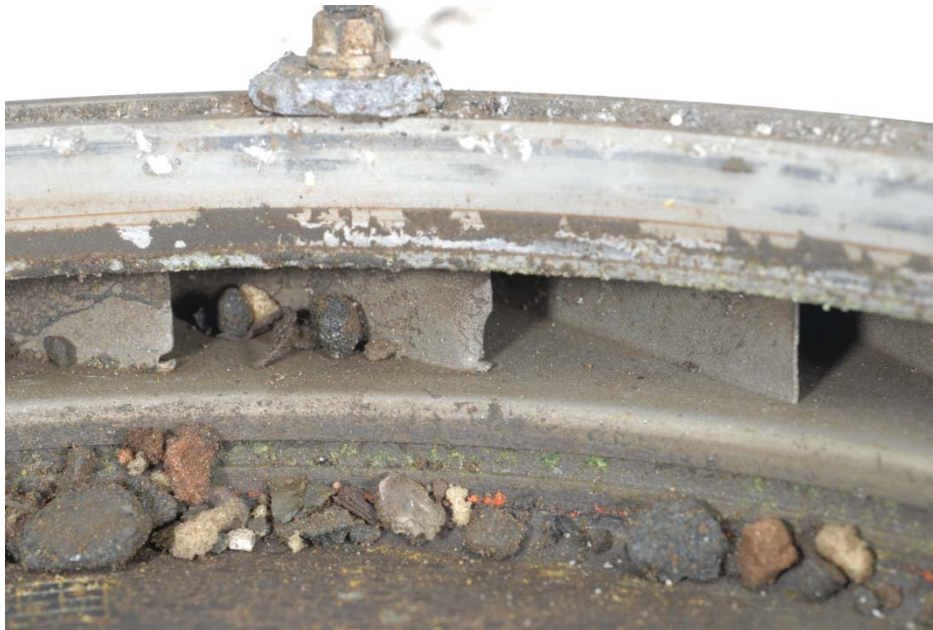
- The first-stage compressor diffuser displayed damage consistent with foreign object damage to the leading edges of most of the vanes. (Figure 304)
  - The first-stage compressor diffuser contained earthen debris between the diffuser vanes.

**Figure 302.** P-79001C, First-Stage Compressor Diffuser, FLA

**Figure 303.** P-79001C, First-Stage Compressor Diffuser, ALF
